## **Background Information**

### **Dunardry Bridge**

**Date 15/09/2025**

The information below was requested by attendees at the online meeting held 28<sup>th</sup> July 2025, which related to the refurbishment of Dunardry Bridge.

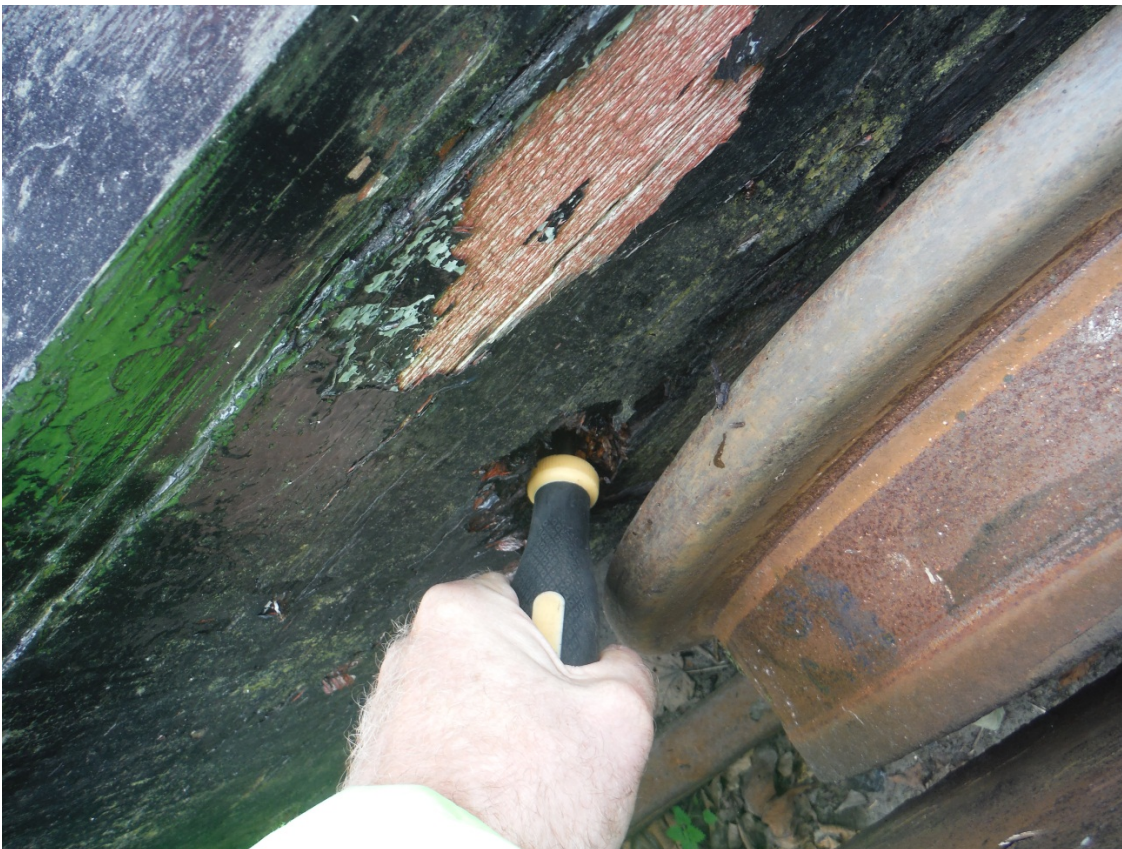
The main beams are in poor condition exhibiting varying degree of timber decay. Beam MB3 appeared to be in a very poor condition and the outer face showed negligible resistance when probed. The inner face was not accessible due to the location of the PFC section.

Decay timber of beam MB3 near back wheel

The deterioration of beams MB3 and MB4 has advanced to the extent that any repair to the existing timber section would not be economically viable.

- Main timber beams MB3 and MB4 should be replaced. Economic viability of timber repairs for beams MB1 and MB2 may be considered but would be unlikely to be cost effective and meet durability requirements. Like for like replacement of these members is recommended.

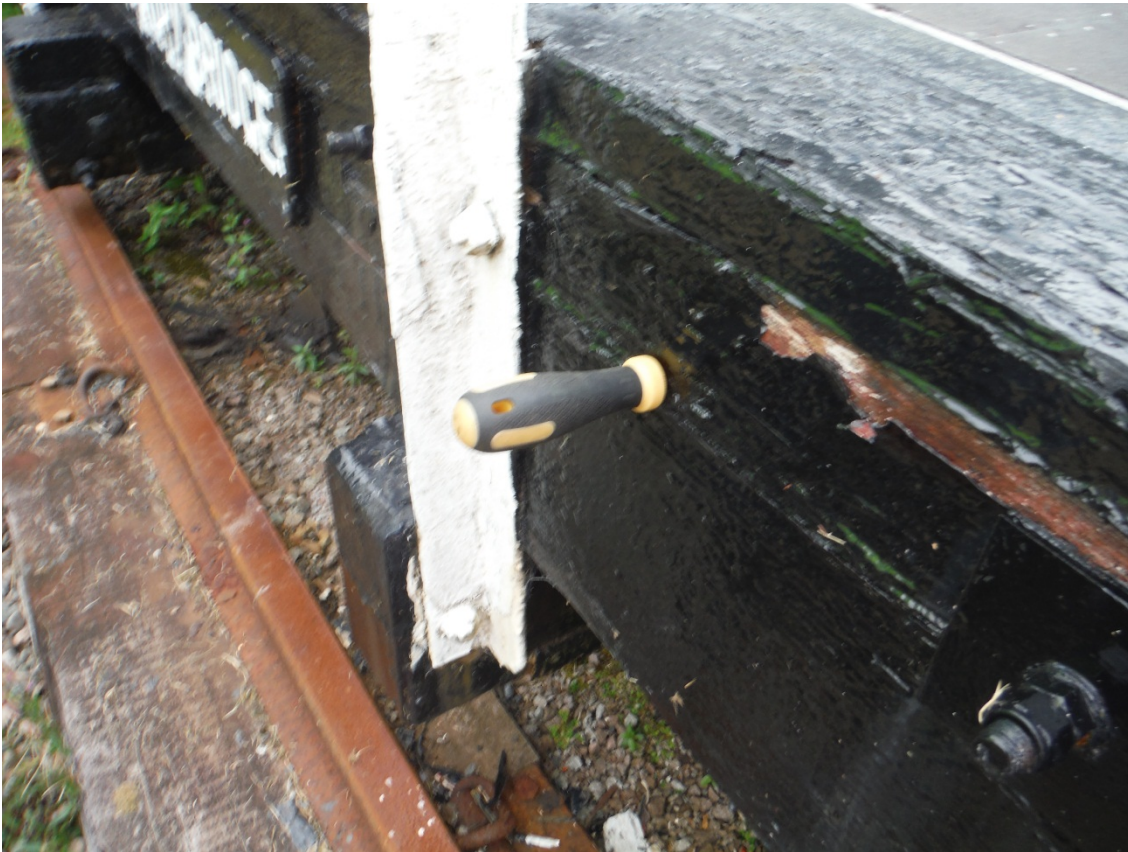
Decayed timber section in beam MB3

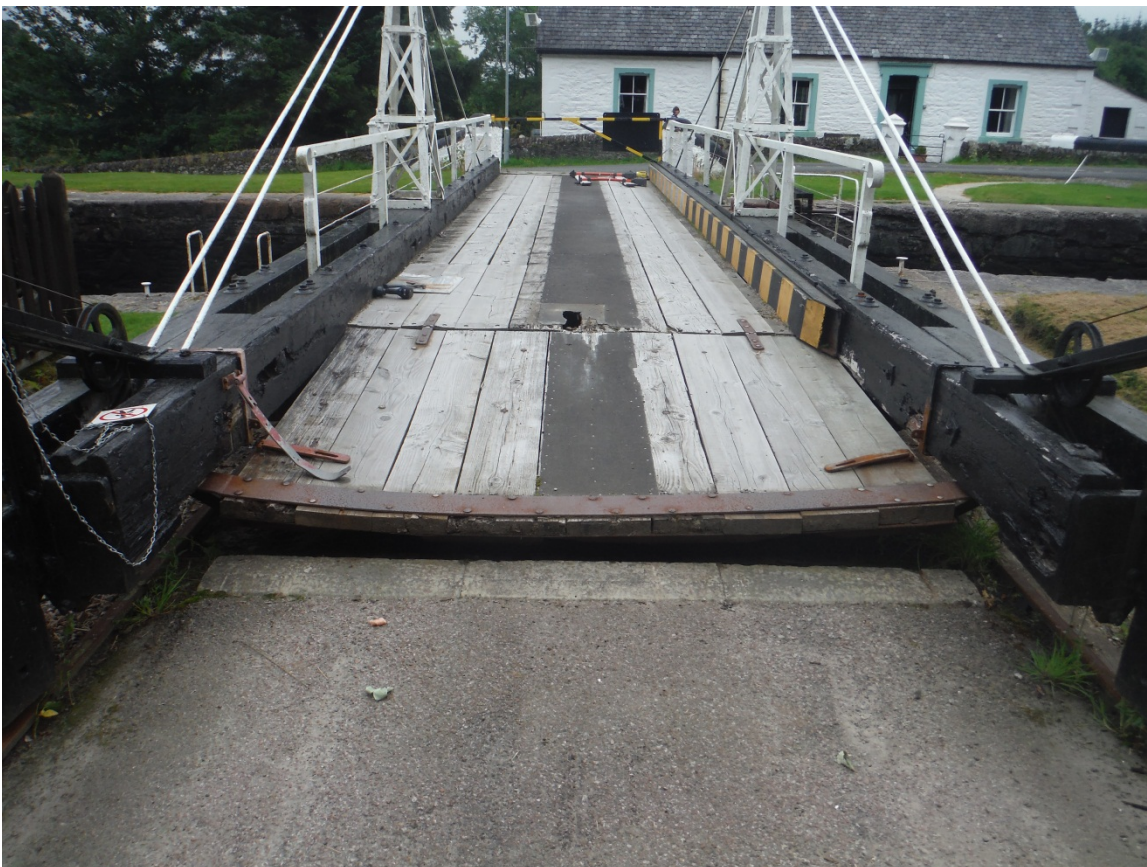
The ramp is hinge fixed to the main deck and operated with assistance of counterweights and pulleys. It is generally in poor condition. The locking system for retracted position appears to be surface corroded throughout. The ramp has deformed into a concave shape. This prevents the timber from meeting the concrete front end nosing to allow a smooth vehicle passage. The underside of the ramp was not accessible for inspection.

Deformed ramp section in raised position

- Bridge driving mechanism should be reused after closer inspection confirms its viability. A new paint protection system will be required.
- The timber ramp deck planks and associated steelwork should be replaced. The counterweight system can be reused.

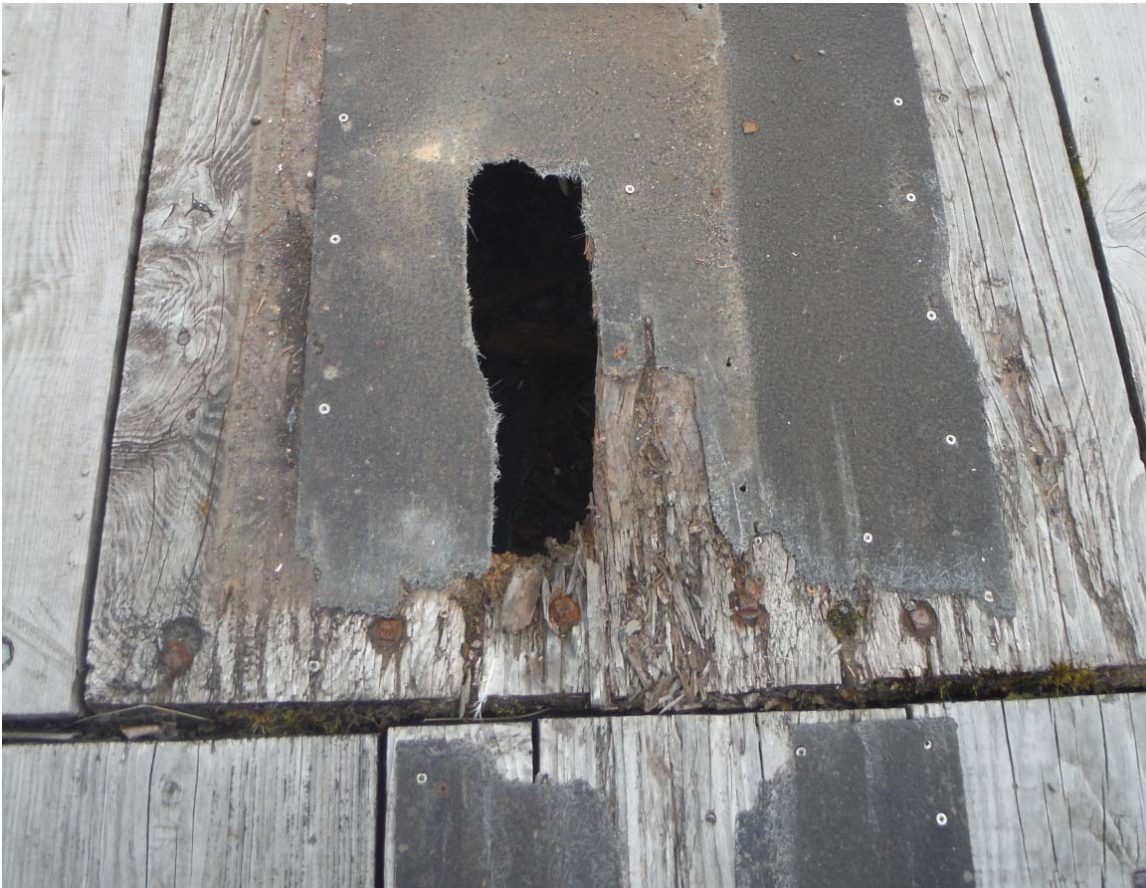
The planks are in fair condition for the age apart from the central ones covered with the strip which are showing signs of timber deterioration at various locations. The extent of deterioration appears to be higher under the strip as it prevents planks from drying. The planks are not jointed leaving gaps up to 10mm between them.

Decayed deck section underneath non slip central strip

- Transverse beams should be closely inspected once the deck planks are removed and individually assessed for their reuse potential.
- Deck planks should be individually inspected and replaced where required. Economic viability of timber repairs for some deck planks may be considered but would be unlikely to be cost effective and meet durability requirements.

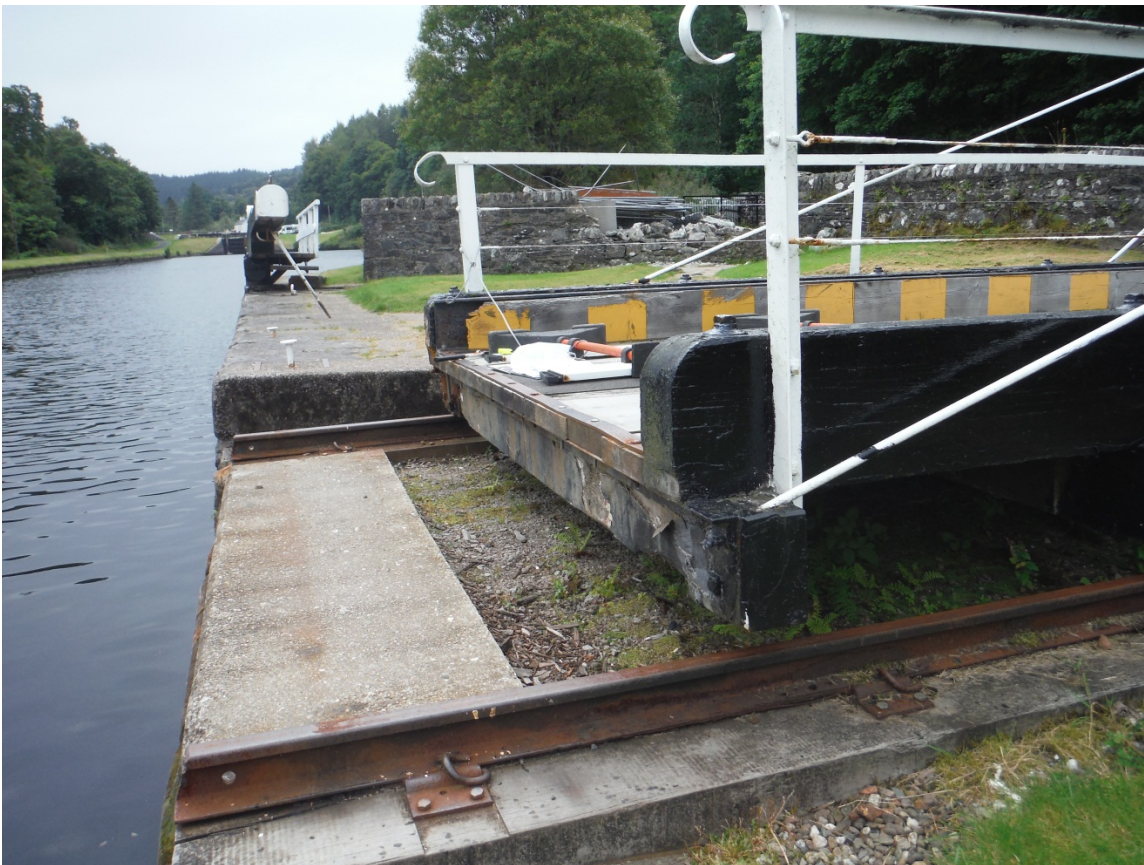
The bridge is launched from the south abutment end, where it is supported by a set of metal rails on timber sleepers which are built into the abutment. The rails appear to be in a fair condition showing signs of corrosion throughout although this appears to be mainly superficial. The timber sleepers appear to be in fair condition although a split was noted at the west end corner.

Front transverse beam showing distress. Timber sleeper split below the rail at the east end

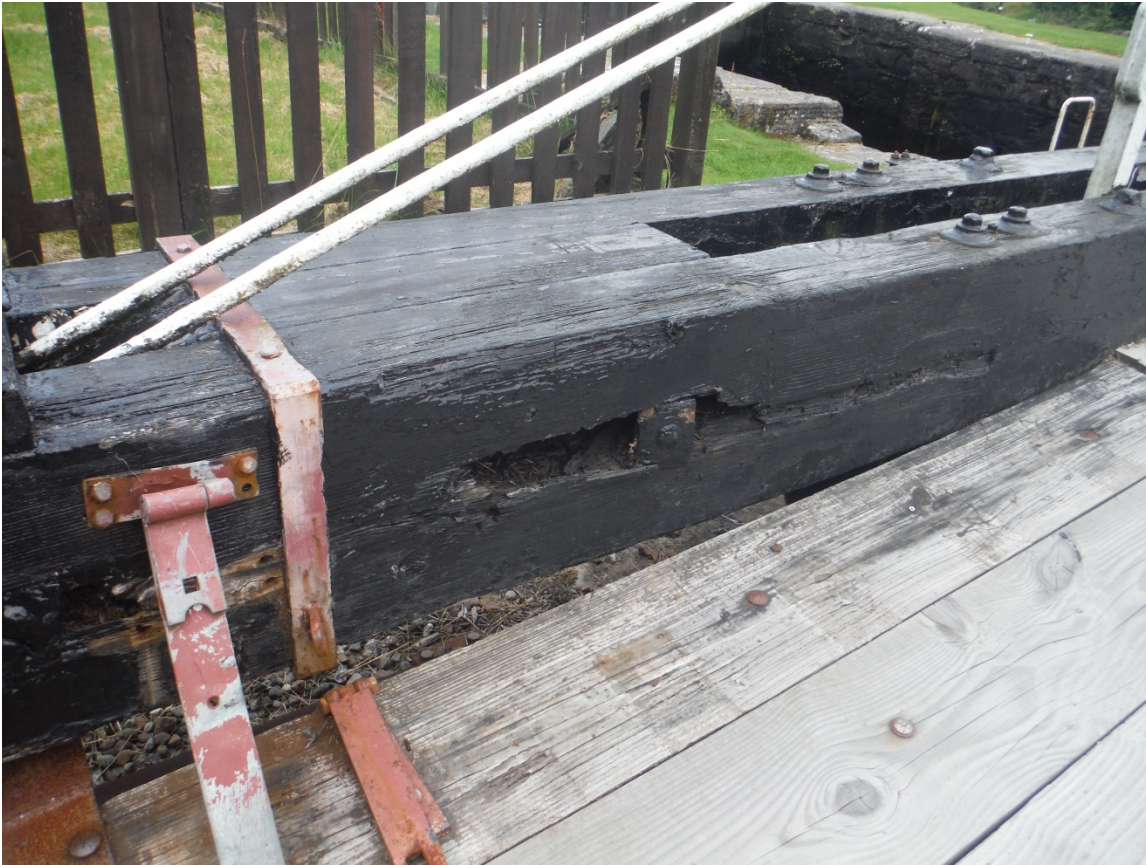
Soft timber sections were found on MB4 and to a lesser extent on Beams MB1 and MB2. It was also noted that the decayed areas of timber were saturated with water. A tapping survey was carried out along the main beams and sections of possible hollow sound were observed particularly to the north ends of beams MB2 and MB1.

Beam MB4 appears to have a longitudinal crack in line with the connecting bolts. This crack was covered by a thick layer of paint making it difficult to determine the extent of the crack.

Decayed end of beam MB4

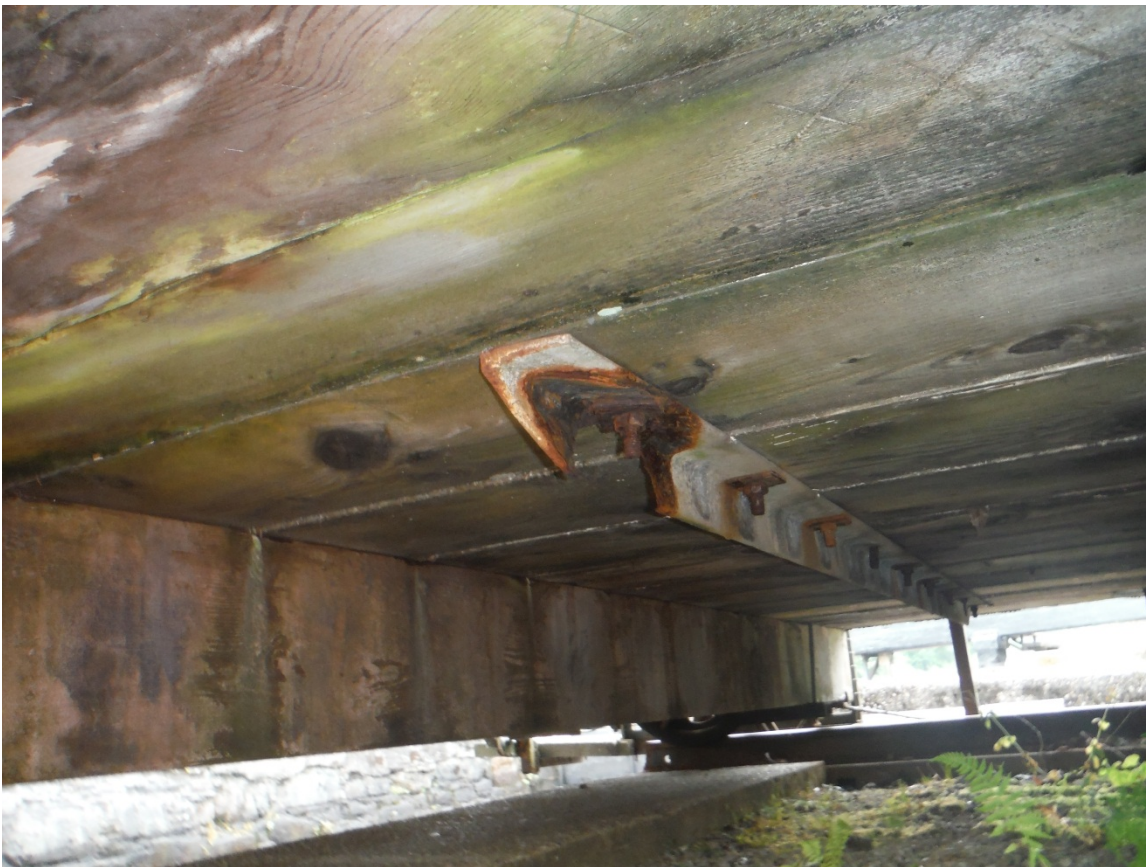
The deck planks are stiffened by 2.5 x 3/8" equal angles half way between the transverse timber beams. Similar to the transverse beams their inspection was limited due to restricted access. Localised corrosion of various degrees was noted throughout. It was evident that the majority of the connecting bolts were corroded due to lack of deck waterproofing and therefore allowing unrestricted water seepage between the deck planks.

Transverse deck stiffener angle sections are showing various level of corrosion which suggests that a number of these may be available for reuse. A large number of connecting bolts were found to be corroded suggesting that most of these should be replaced.

Loss of section at angle deck stiffener and corroded bolts

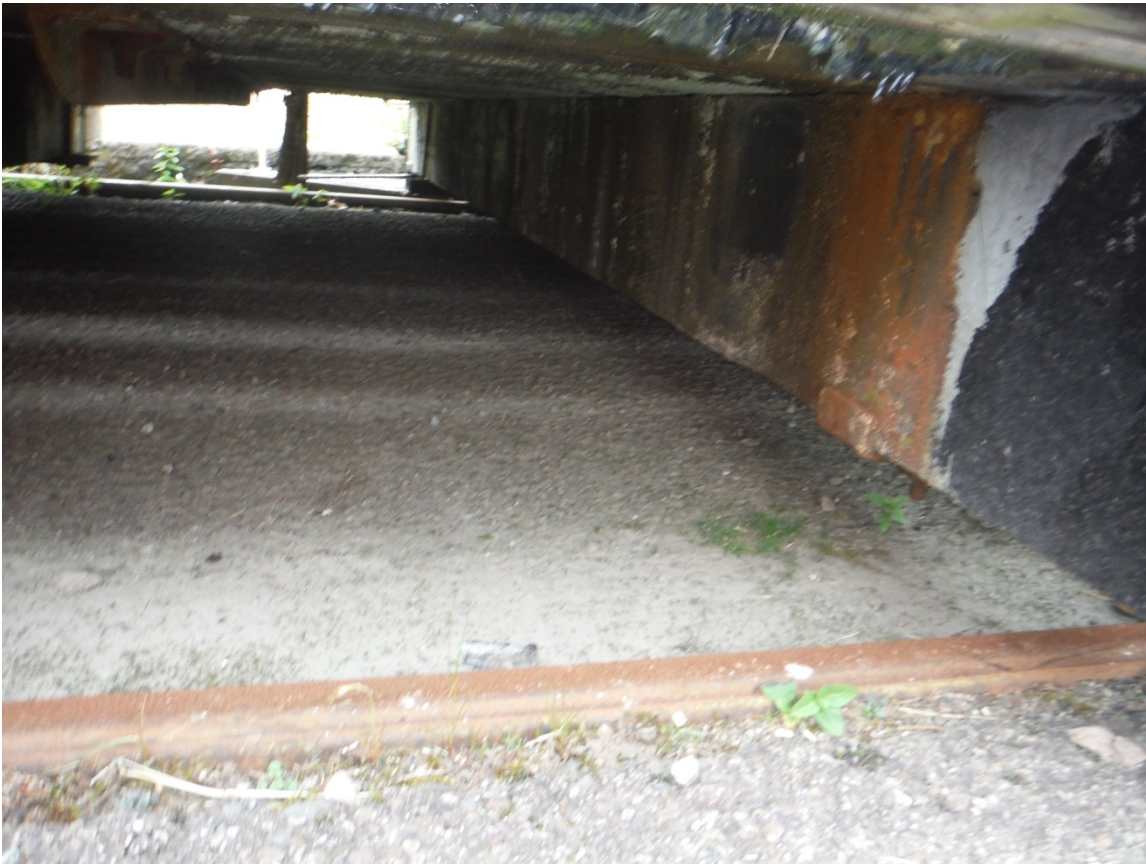
Transverse beam staining

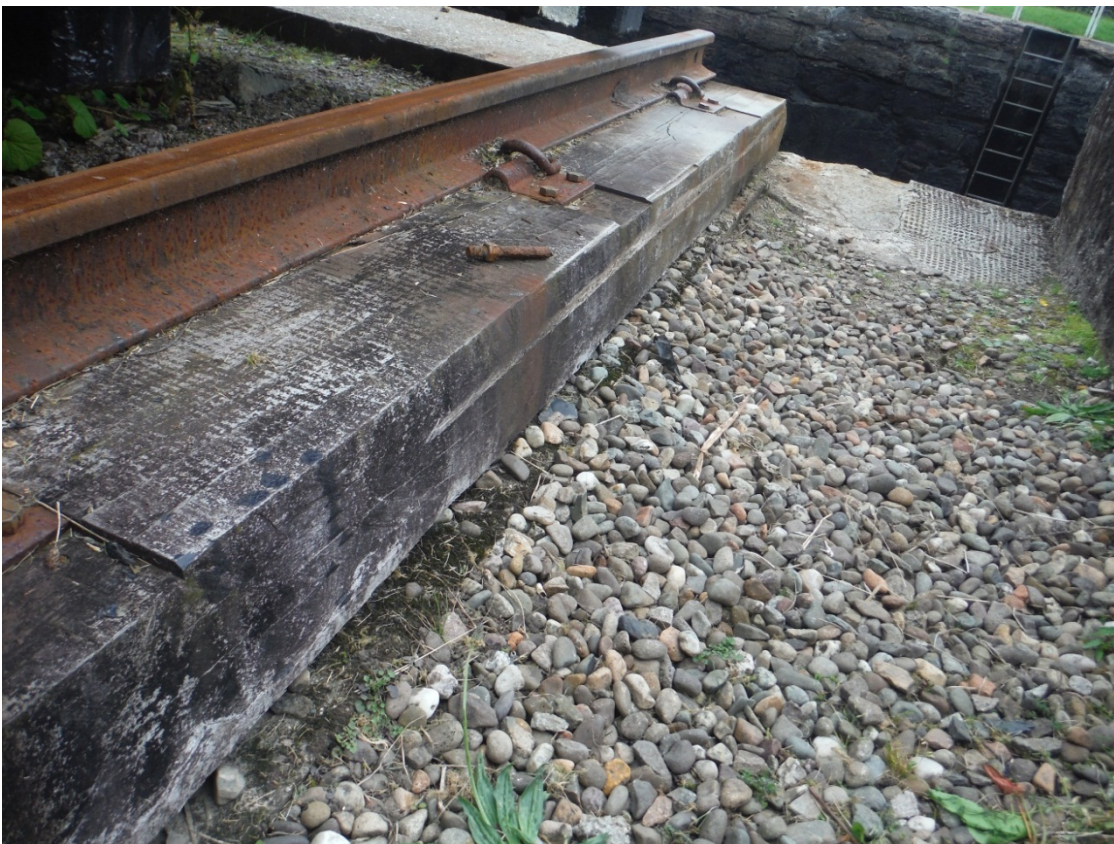
It has been reported by the bridge operator that the mechanism is difficult to operate and particularly at the final stage before it reaches the north support. Although the mechanism could not be inspected from underneath to eliminate other possible causes, the most likely cause of additional friction is the additional weight contributed by the PFC section installed along beam MB3. A clear mark of this friction is visible on the east face of the rail timber support. Furthermore, observing the moment when the bridge reaches the end of travel at the east corner, it is apparent that the bridge hits the supporting wedge low before stepping on and sliding into the final position. At the same time the wedge at the west side hardly supports the other corner of the bridge.

The above observations suggest that the whole superstructure is twisted and leaning to the east. This distortion is causing a series of problems such as difficulties in driving due to additional friction, uneven tension in the tie rods and excessive wear of the eastern bearing pad and even possible lift-off at the western bearing pad.

Friction marks caused by driving mechanism along the timber sleeper east face

In order to restore balance to the bridge the steel PFC including the infilling plank along beam MB3 should be permanently removed. This should remove the existing problems associated with the use of the mechanism, twisting of the deck and uneven bearing on the northern supports. The bridge operating mechanism should also be closely inspected during the bridge repair. Due to simplicity of its mechanism it is unlikely that the foregoing problems should persist once the PFC section is removed and the weight of the bridge restored to its original alignment.

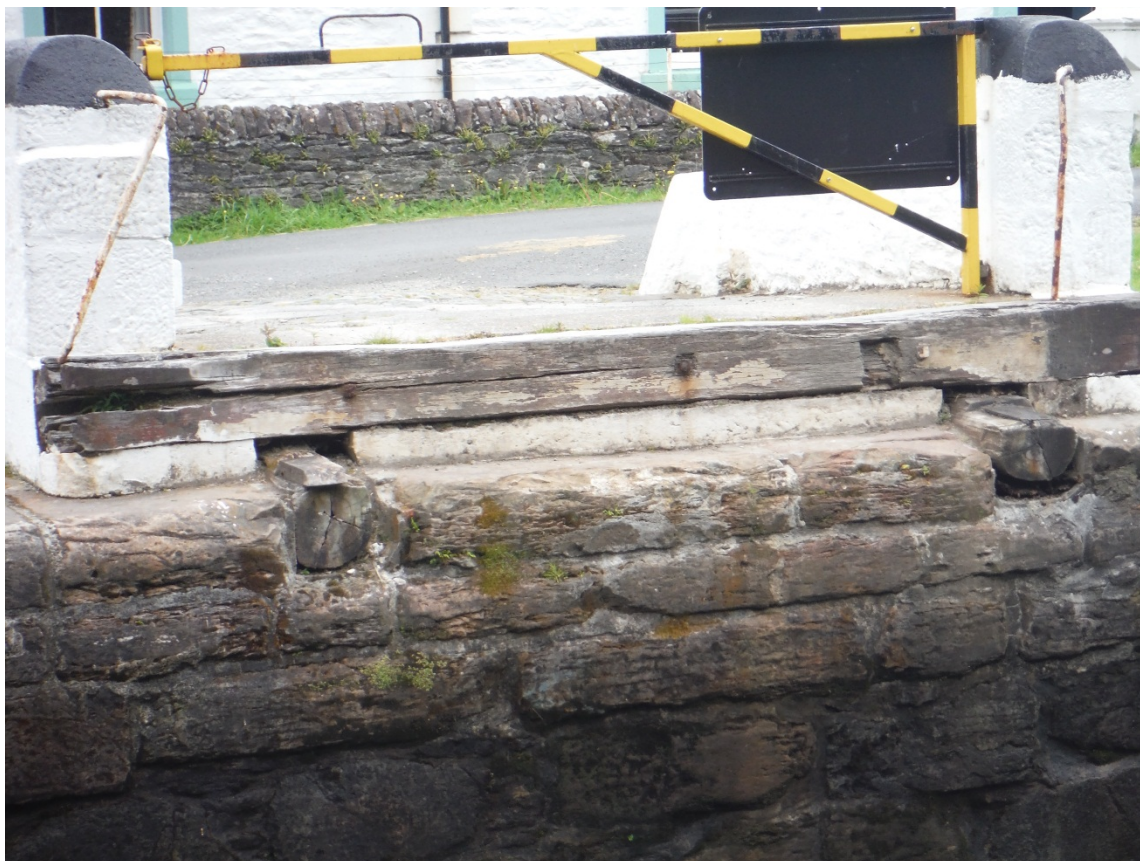
The timber logs are in a poor condition. The western support is well seated within the masonry but has large cracks evident across its section. At the east support, the log is worn and undermined so that a large gap is visible between the bottom of the timber and the masonry. The top of the section has been worn or cut flat. The timber wedge supports are unevenly worn with the eastern timber wedge significantly more worn than the western one.

The timber support sections are in fair to poor condition, particularly the supporting wedge at the east end. In order to achieve a minimum 25 service life these timber elements should be replaced.

Uneven wear of timber supports and deteriorated timber 'log' supports at the north abutments

- Replace the timber log and wedge supports at the north abutment.
- Proposals for like for like replacement of required elements should be submitted for review by Historic Scotland.

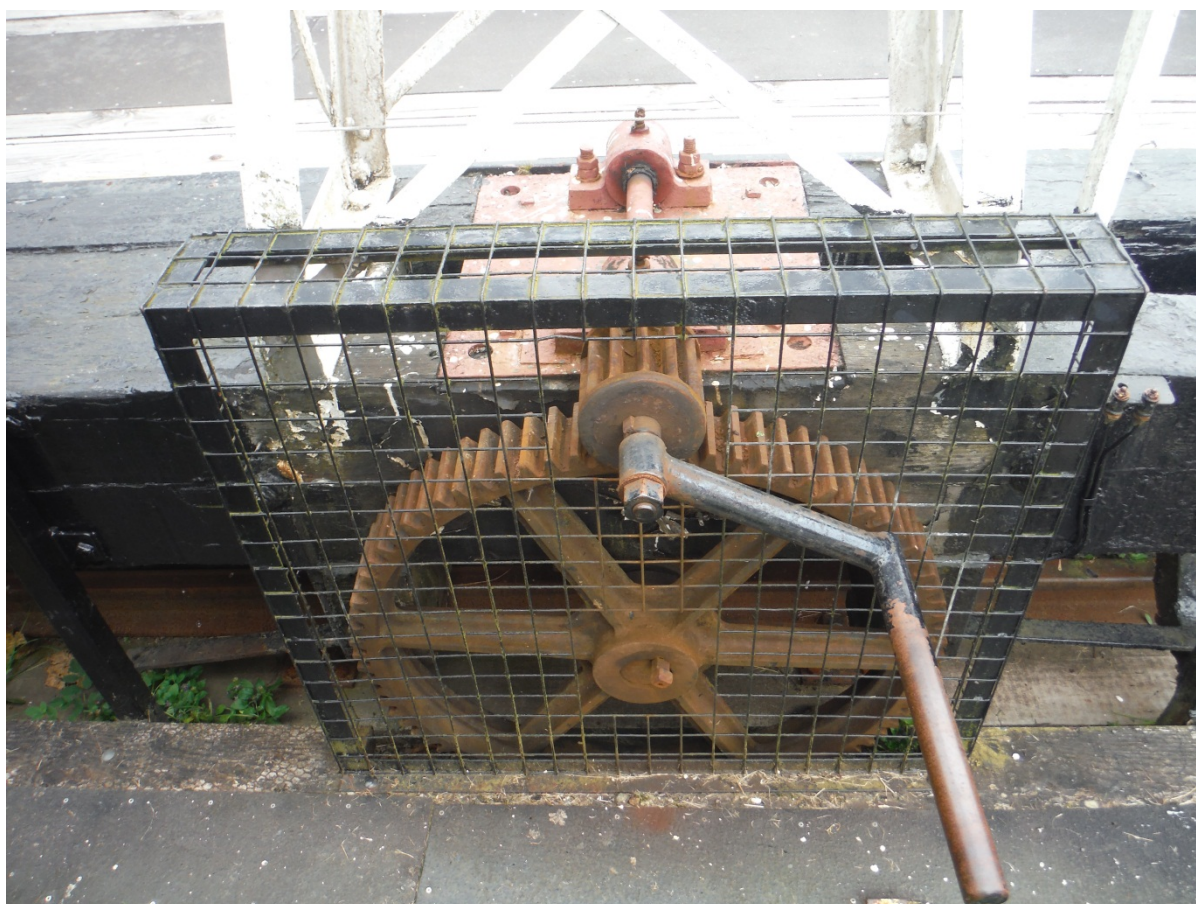
The gear wheels consist of a simple mechanism which drives railway type wheels by turning a windlass. The wheels and the gear mechanism appear to be in a fairly good order for its age although there is surface corrosion throughout.

The rolling mechanism is generally in good condition although its paint protective system appears to have long gone and is showing corrosion throughout including the rails and wheels.

Rolling mechanism

Corrosion of the rolling mechanism appears to be superficial. A new paint protection system should be applied. Prior to this being applied, the mechanism should be checked for signs of superficial damage, such as broken cog teeth, with local repairs carried out as required.

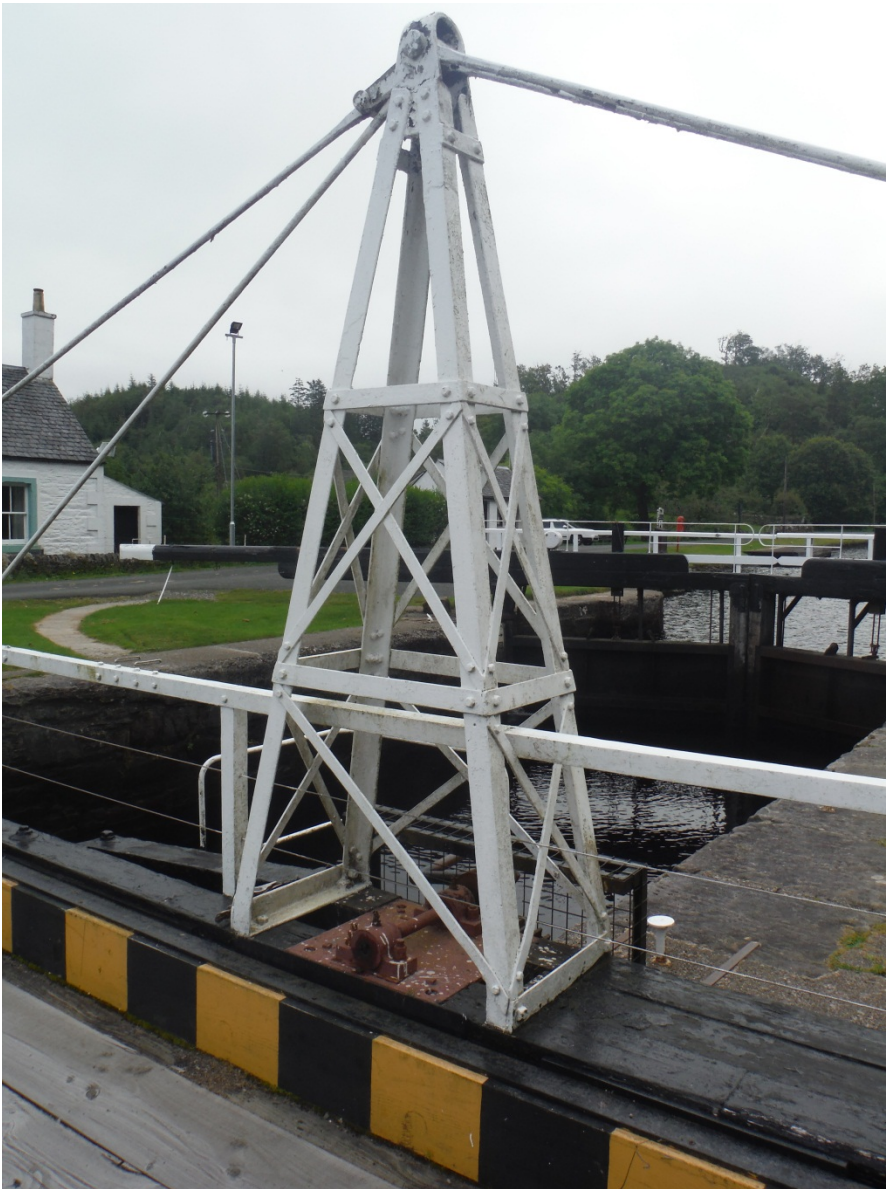
The twin lattice towers are made of metal equal angle sections with flat diagonal bracings. They are painted throughout and appear to be in good condition.

The paint protective system is generally in fair condition with some flaky areas at the top of the tower and some supporting members at the base.

Metal lattice tower

- All metalwork associated with the deck including lattice tower and tie rods should be inspected and reused unless extensive corrosion and loss of section are present. Metalwork should be repainted.
